Research paper / Praca badawcza

Issues related to the cessation of special production in chemical plants

Michał Kaczorowski*, Piotr Prasula, Piotr Kasprzak

Military Institute of Armament Technology, 7 prym. S. Wyszyńskiego Street, 05-220 Zielonka, Poland

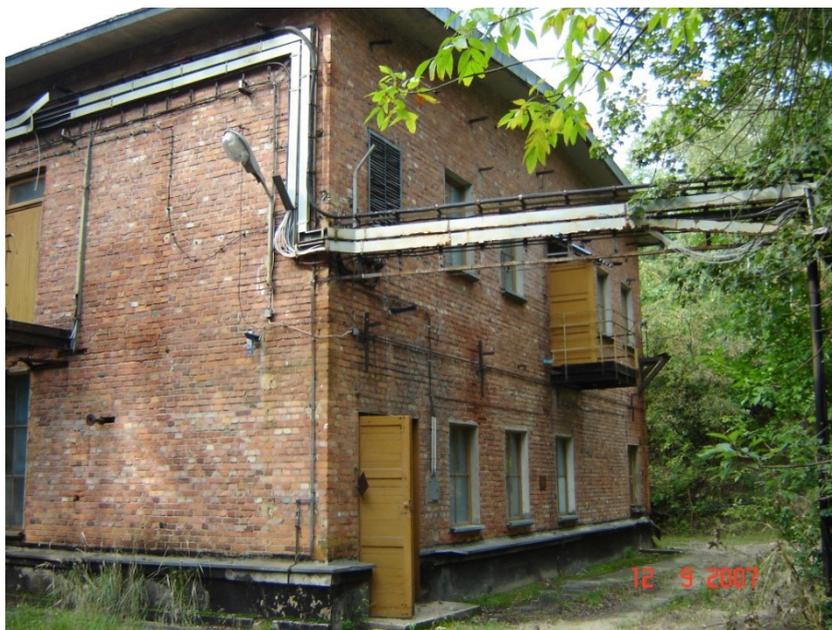
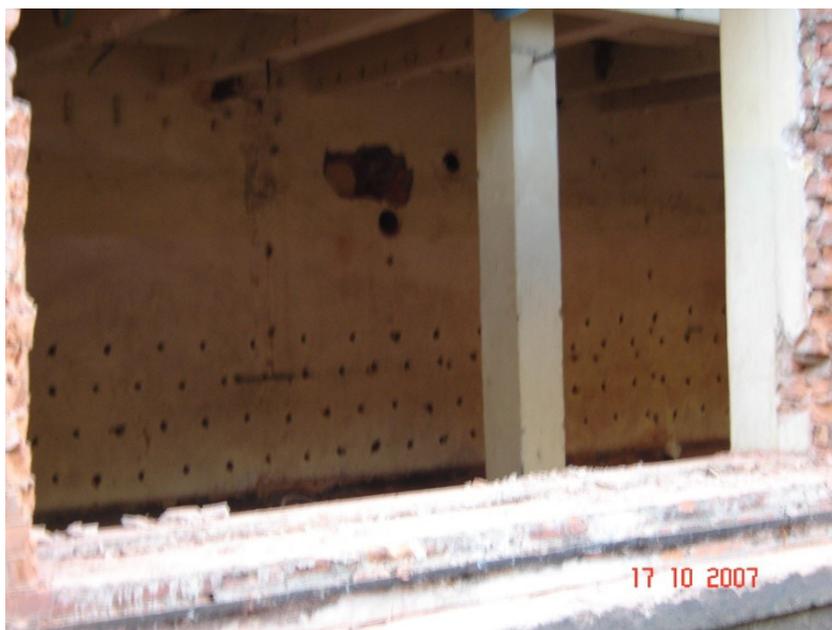
Figure 1. Nitration building: (a) general view; (b) nitration building wall with demolition charge holes

In 2007, the demolition of Department 100 buildings, by a specialized company, was ordered. Due to dense reforestation, the buildings were not cleaned by firing before demolition. The company decided to demolish the buildings using explosive microcharges. Before demolition, the building was washed with water daily and the blasting holes were drilled under a water stream. First, the floors and equipment foundations inside the building and then the internal and external walls were demolished. During detonation of the microcharges, effects of micro-remnants of hexogen were observed (increased noise and intensified explosive effect). The debris was loaded onto tipper trucks under a stream of water and transported to the local wastewater treatment plant. The debris was used as a base course for the slab road to facilitate the restoration of the settling tank.

Figure 1 shows the view of the nitration building prepared for demolition and Figure 2 shows the effects of demolition of parts of the building. Most buildings of Department 100 were demolished using this method, except for some auxiliary buildings (where no hexogen production was carried out) and reinforced concrete storage bunkers located deeper in the woods. This example of cessation of explosive production can be considered correct, prioritising the safety of personnel and property.

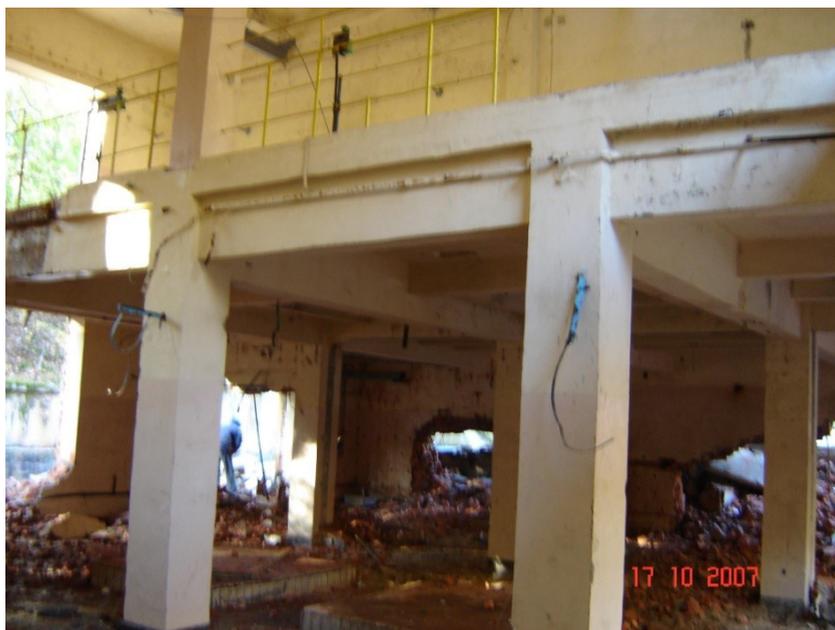
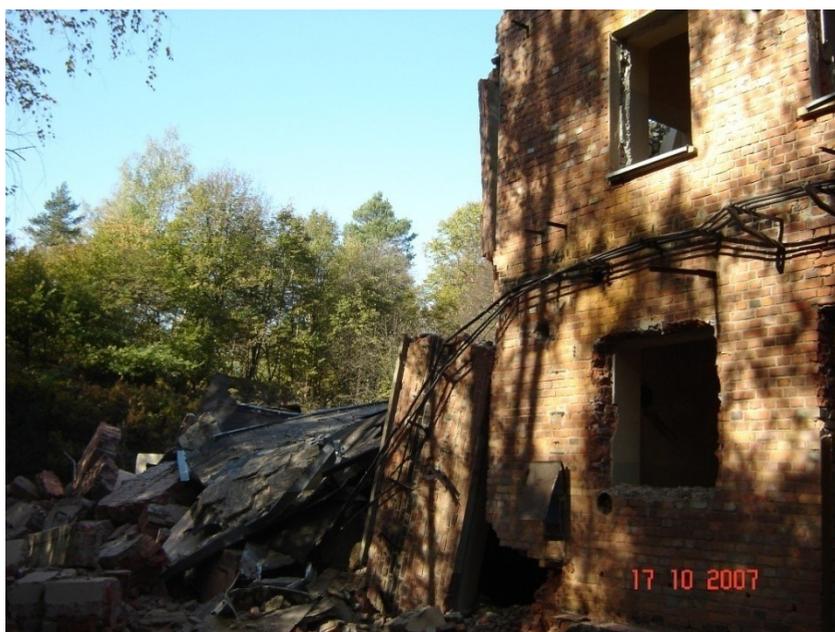
Figure 2. Nitration building during demolition: (a) demolished side walls, prepared for further demolition, (b) view after partial demolition

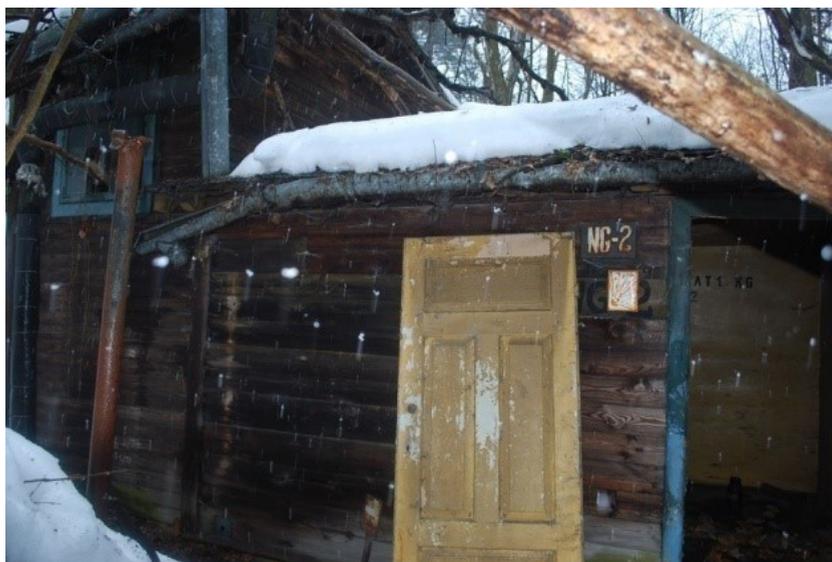
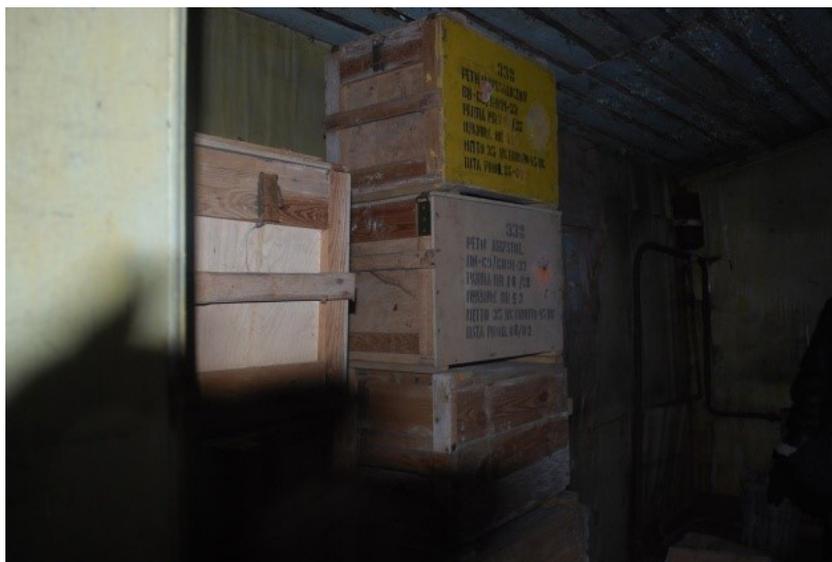
Figure 3. The production building in Pronit plant: (a) outside view, (b) interior with explosives transport packaging

Figures 3(a) and 3(b) show the view of the production building at the Pionki plant and the interior with the wooden crates used for transporting explosives. Figure 4 shows the interior of the building, including production equipment and the remainder of reagents in glass and plastic containers. Figure 5 shows the interior of the production building and the press, where the fatal accident took place.

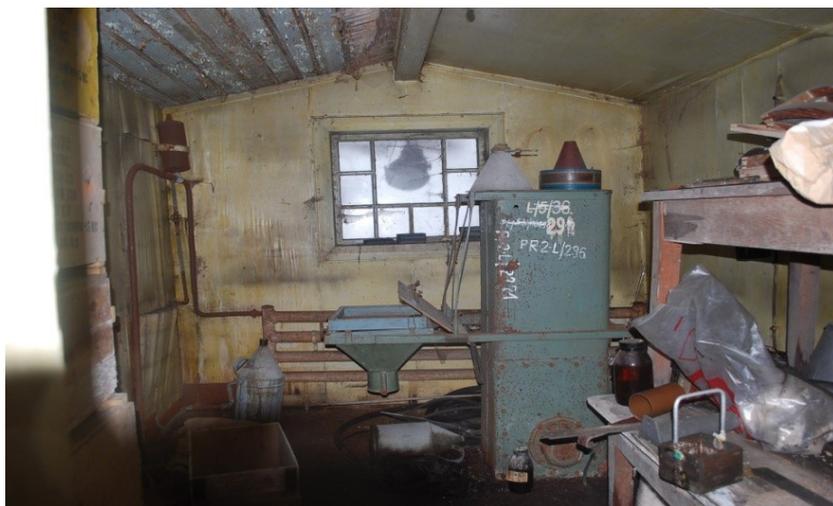
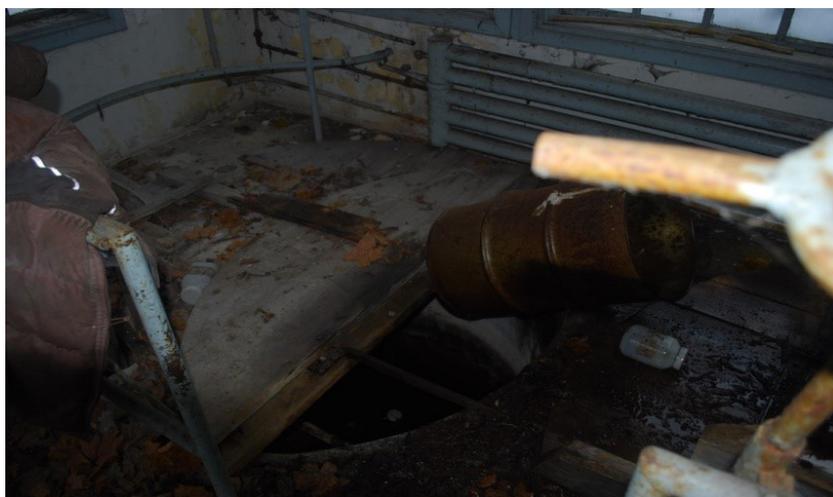
Figure 4. Interior of the building including the production equipment and the remainders of reagents in glass (a) and plastic containers and metal drums (b)

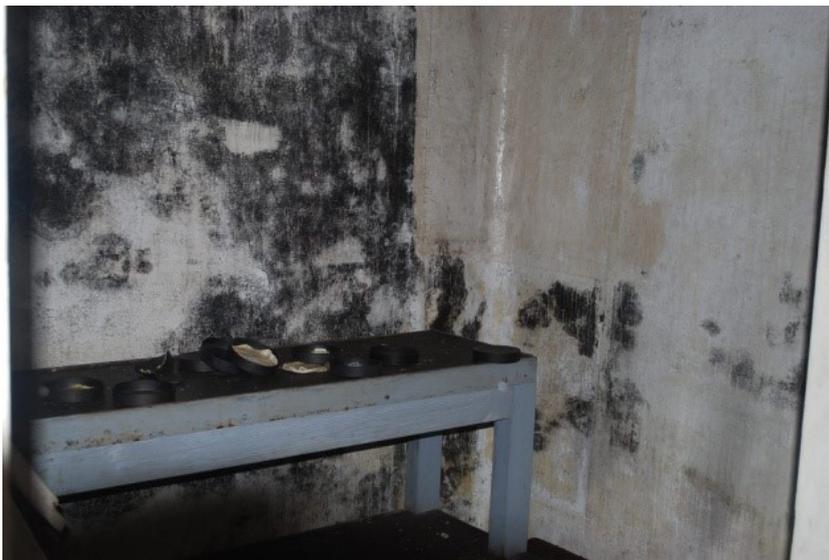
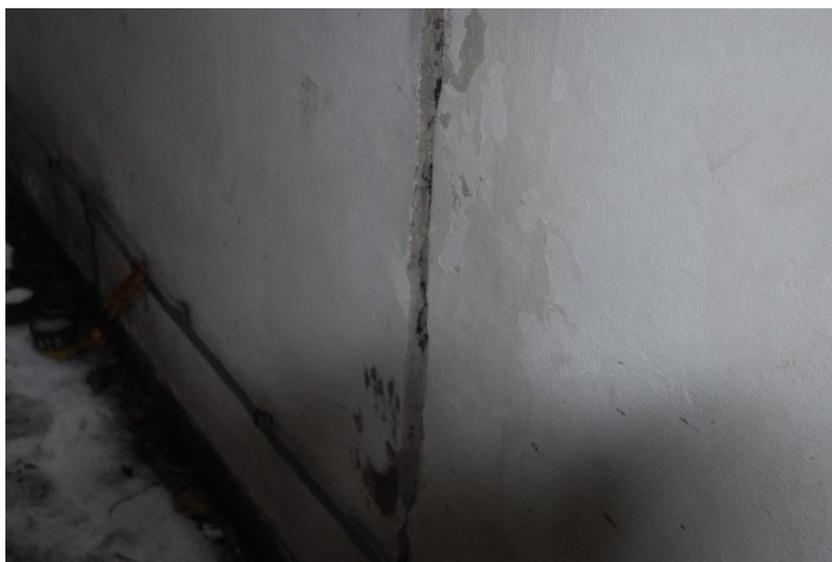
Figure 5. Production building: (a) table with scale pans for explosives; (b) drift in which the fatal accident took place

The production process at the department described below is key to the case. The walls and floors of the production facility were rinsed with water before and after every shift. The water was drained to a sedimentation tank *via* concrete troughs. Because of this, the presence of explosives in the floors and under the floors, in the production facilities, as well as near and under the troughs needed to be considered. In 2011, the plant advertised for tenders to demolish part of the department's buildings. The cheapest offer was selected and the tender was awarded to a contractor without a license to work with explosives. As a result, the tender was invalidated, and after several

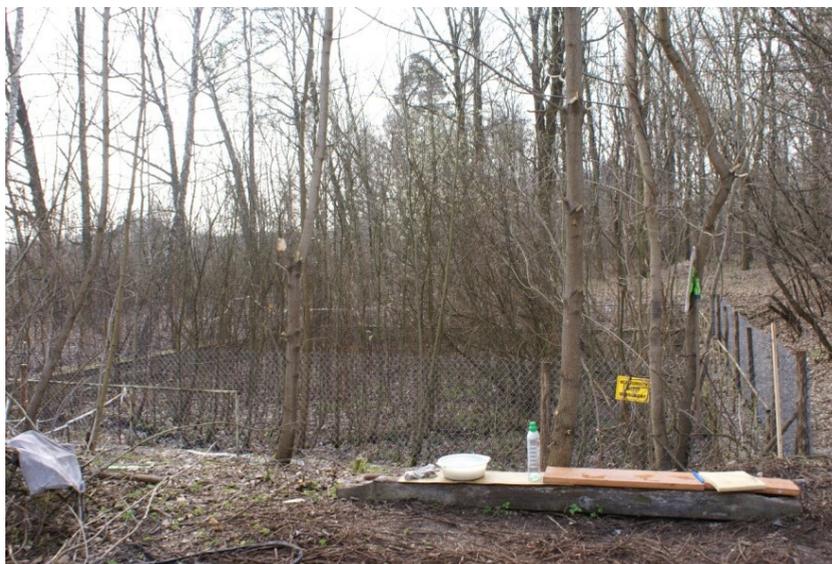
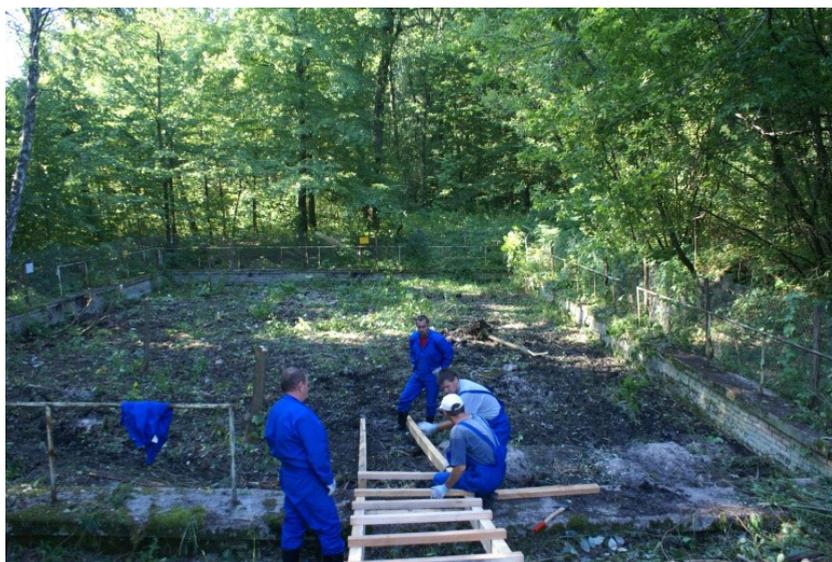
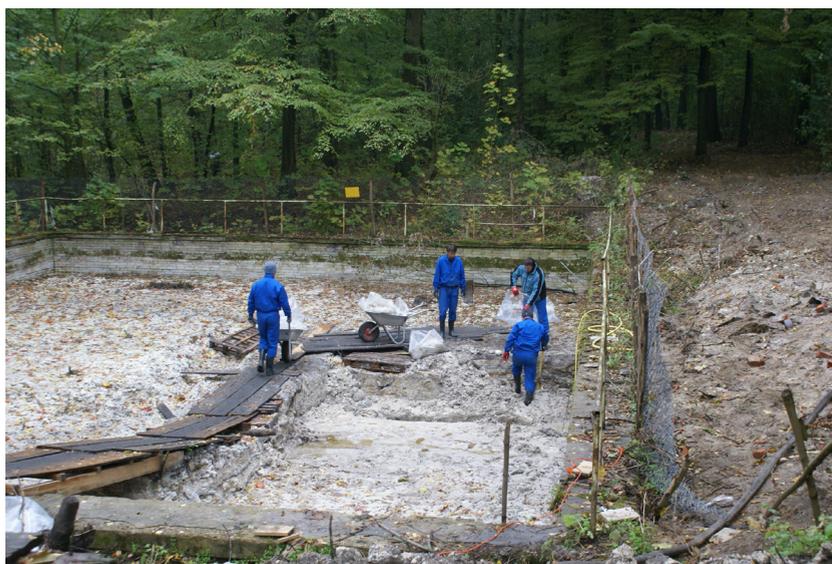
Figure 6. View of the production area: (a) open tank containing nitrocellulose before commencing works; (b) tank after tree felling; (c) tank cleaning, nitrocellulose rinsed with water, staff wearing anti-static clothing and using non-sparking tools

In 2012, an explosion occurred in the nitrocellulose production department, killing two people. The Municipal Council attempted to locate the contaminated areas, and secure the means for decontamination and disposal of nitrocellulose. Approximately 240 tonnes of nitrocellulose were identified. In 2015, following a successful tender, decontamination was attempted by the Military Institute of Armament Technology. Within 4 months, the nitrocellulose was extracted and removed from the plant. The biggest hazard was a settling tank filled with nitrocellulose. The explosives were found in the inspection chambers, drain pipes and wooden troughs removing rinsing water from the sector. Deposited nitrocellulose was found down to a depth of approximately 80 cm under the wooden troughs. During normal production, the troughs were periodically cleaned, and their contents thrown aside, forming nitrocellulose mounds. Figures 6 and 7 show the location at the production area where nitrocellulose was left in the tank, inspection chambers and drain pipes. Figure 8 shows nitrocellulose loading into certified transport containers.

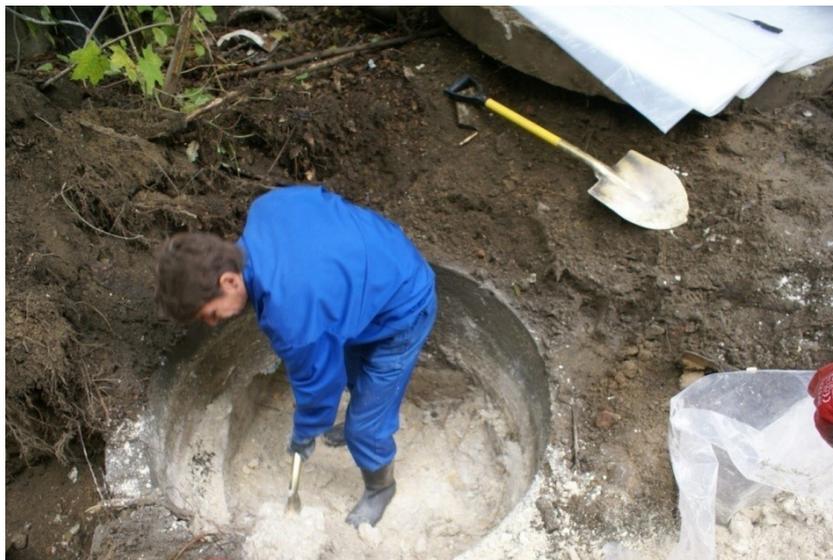
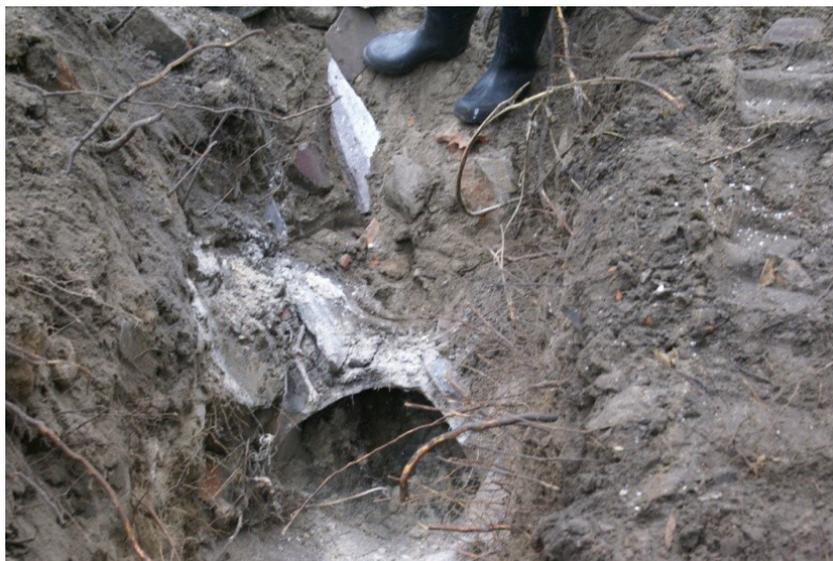
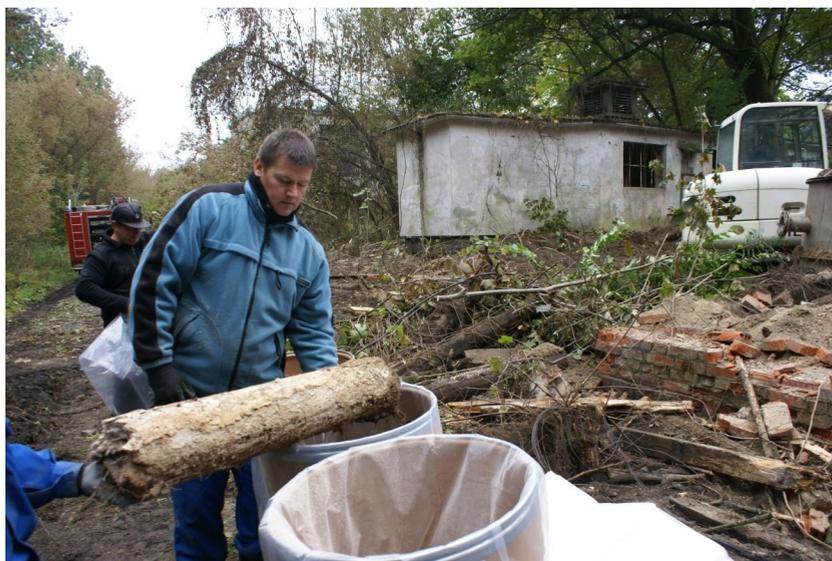
Figure 7. View of the production area: (a) inspection chamber containing nitrocellulose – material removal process; (b) drain pipe containing explosive sediments; (c) charge removed from the drain pipe formed by nitrocellulose deposits inside the pipe

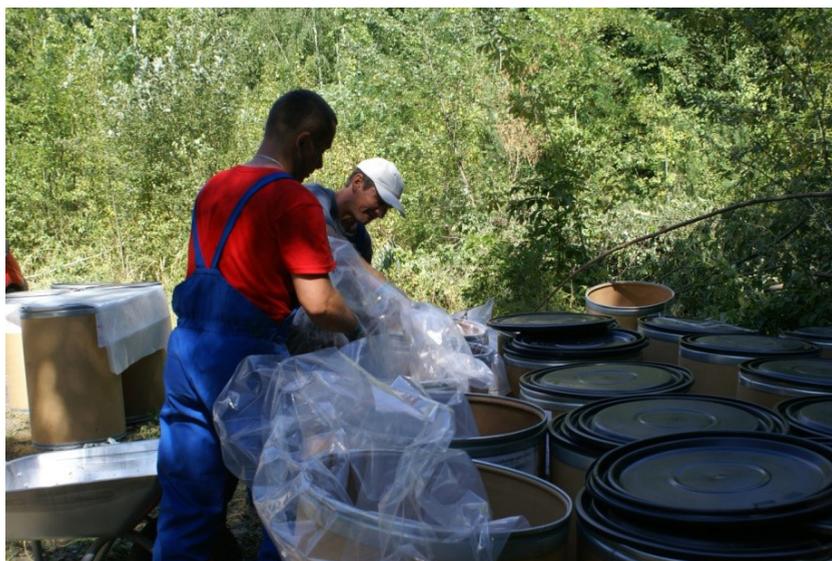
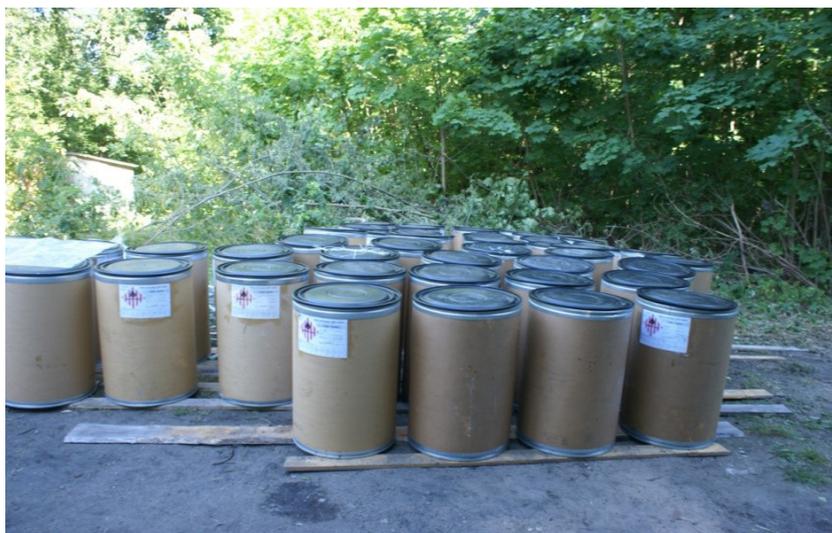
Figure 8. Placing the extracted nitrocellulose after immersing it in water into an internal bag (a) water-proof, anti-static protecting the content placed into cardboard drums, (b) transport containers as required by the agreement concerning the International Carriage of Dangerous Goods by Road (ADR)

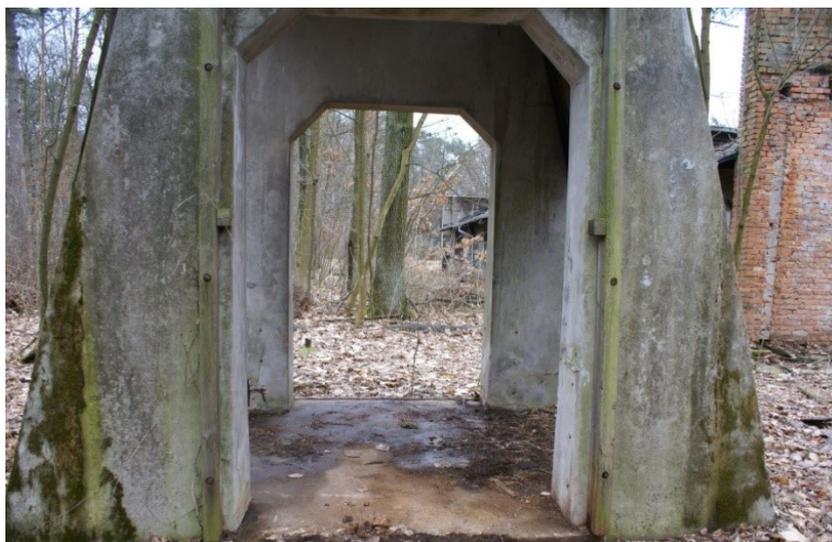
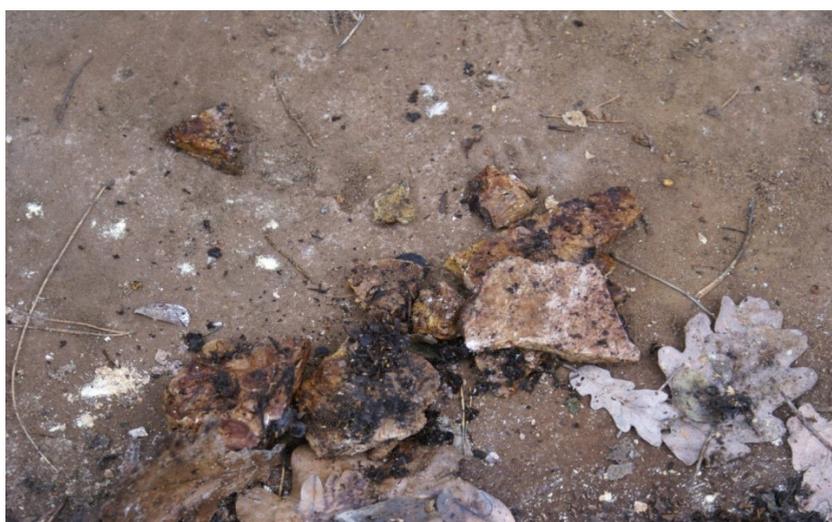
Figure 9. Trinitrotoluene melting plant (a) and the remaining explosives found near the melting plant (b); the physical and chemical analysis showed trinitrotoluene removed from the shells

As it turned out in 2016, in the area handed over by the Municipal Council to the MESKO branch in Pionki, there is an undisclosed, overgrown former trinitrotoluene melting plant. A vat with 335 kg of trinitrotoluene was found at the location. An on-site visit carried out this year showed pieces of trinitrotoluene and tetralite under the leaf litter. Figure 9 shows the location of the melting plant and the remaining explosives.
